**Flood Control Project Maintenance  
Levee Inspections**

**Fall 2018 Levee Maintenance Deficiency Summary Report**

**Sacramento River Basin**

**Flood Control Project Maintenance  
Levee Inspections****LMA District Cover Sheet****Fall 2018 Levee Inspection Results****Reclamation District No. 0003 Grand Island**

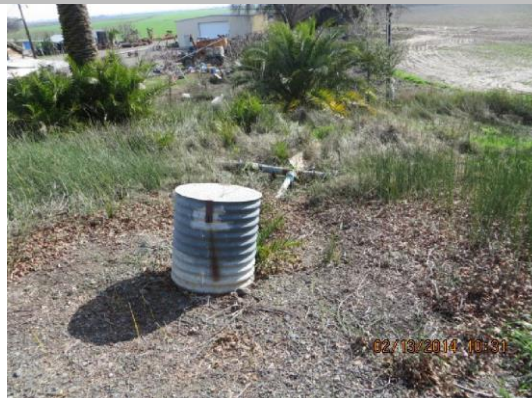
Photo 2 of 3 : UCIP\_FA\_2018\_53483\_54545.jpg

FS\_ID:53483  
DS\_ID:22163  
EP\_NO: N/A  
Repair Type: Urgent  
Crossing Status: Found  
UCIP Comments: 07/20/2018 Everything appears to be the same as last time. No changes have been made. Most of the pipe still remains. Did not see any active leakage. Tape was wrapped around the pipe connections on the LS in 2016 to prevent leaking. Crossing remains "Urgent" due to the pipe integrity issues that have not been fully addressed. (DWR UCIP - A. McDonald)09/29/2017 Received updated photo from DWR levee inspector, D. Torres, and photo shows part or all of the pipe has been removed. Inspector could not verify proper abandonment. Need to coordinate with LMA and owner to determine supporting documentation to support the work completed at this site. This crossing remains urgent due to the details of the extent of the removal. No permit was found to authorizing levee work. (DWR UCIP - O. Magana) 07/06/2016 Pipe diversion off main steam on LS has tape wrapped around its connections, a possible attempt to contain past leakage. Did not see active leakage. Slight sloughing on LS slope at diversion manifold. (DWR UCIP - kfazel)02/13/2014 Pipe disconnected or diverted on LS shoulder and leaking. Water runs down LS slope freely causing erosion. Siphon breaker not visible in CMP riser. Walkway to pump in poor structural condition. (DWR UCIP - pamatya)

24-inch CMP riser for siphon breaker on LS shoulder.

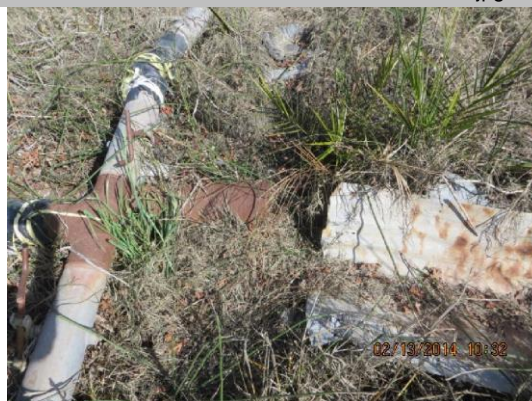
Photo 3 of 3 : UCIP\_FA\_2018\_53483\_54544.jpg

UCIP Comments: 07/20/2018 Everything appears to be the same as last time. No changes have been made. Most of the pipe still remains. Did not see any active leakage. Tape was wrapped around the pipe connections on the LS in 2016 to prevent leaking. Crossing remains "Urgent" due to the pipe integrity issues that have not been fully addressed. (DWR UCIP - A. McDonald)09/29/2017 Received updated photo from DWR levee inspector, D. Torres, and photo shows part or all of the pipe has been removed. Inspector could not verify proper abandonment. Need to coordinate with LMA and owner to determine supporting documentation to support the work completed at this site. This crossing remains urgent due to the details of the extent of the removal. No permit was found to authorizing levee work. (DWR UCIP - O. Magana) 07/06/2016 Pipe diversion off main steam on LS has tape wrapped around its connections, a possible attempt to contain past leakage. Did not see active leakage. Slight sloughing on LS slope at diversion manifold. (DWR UCIP - kfazel)02/13/2014 Pipe disconnected or diverted on LS shoulder and leaking. Water runs down LS slope freely causing erosion. Siphon breaker not visible in CMP riser. Walkway to pump in poor structural condition. (DWR UCIP - pamatya)

Pipe diversion manifold just below siphon breaker on LS slope. Tin diverts water downslope.

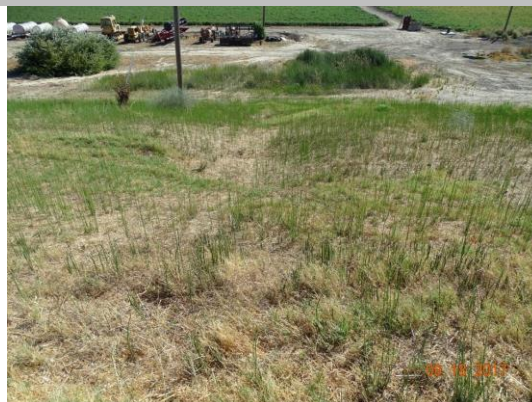
Photo 1 of 1 : FA\_2018\_RD0003\_24\_83\_20180925\_00071.jpg

LM Start	4.87	Rating **	M	Issue No.	83
LM End	4.87	Issue Type +	Ma	Location *	LS
Category	Earthen Levee			GPS Latitude/Longitude	
				Start	End
Item	Slope Stability			38.245903 °	38.245903 °
				-121.600851 °	-121.600851 °
DWR ID	DWR_RD0003_01_f_2017_83				
Comment Code					
S1 : Repair slope instability.					
Inspector Comment					
Landside slope has a depression.

Looking east on landside slope.

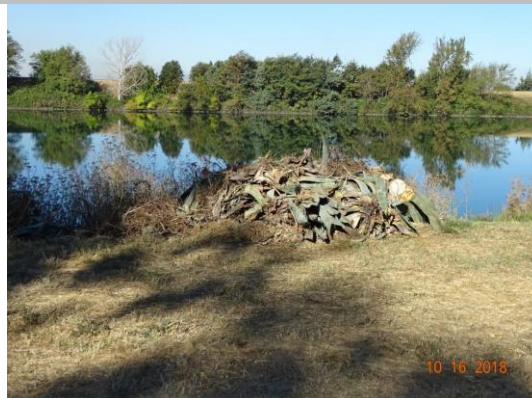
Photo 1 of 1 : FA\_2018\_RD0003\_24\_81\_20181017\_00164.jpg

LM Start	5.08	Rating **	M	Issue No.	81
LM End	5.08	Issue Type +	En	Location *	WS
Category	Earthen Levee			GPS Latitude/Longitude	
				Start	End
Item	Encroachments			38.242857 °	38.242857 °
				-121.600823 °	-121.600823 °
DWR ID	DWR_RD0003_01_f_2018_81				
Comment Code					
MA : Material					
Inspector Comment					
Century plant should be removed from waterside hinge.

View of century plant on the water side hinge point (October 2018).

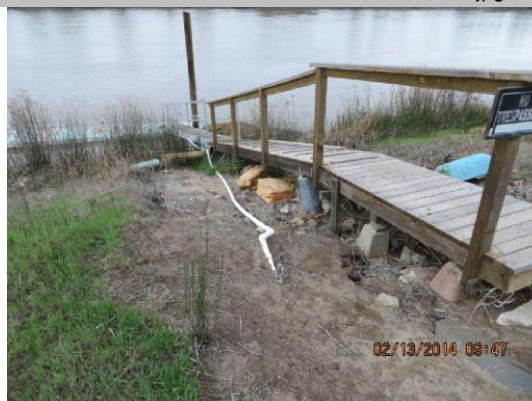
Photo 1 of 3 : UCIP\_FA\_2018\_31286\_57295.jpg

LM Start	5.10	Rating **	M	Issue No.	200	
LM End	5.10	Issue Type +	En	Location *		
Category	Supplemental			GPS Latitude/Longitude		
				Start	End	
Item	DWR UCIP Field Study			38.242649 °	38.242649 °	
				-121.600854 °	-121.600854 °	
DWR ID	24837					
Comment Code						
Inspector Comment						
FS_ID:31286 DS_ID:24837 EP_NO: N/A Repair Type: Non-Urgent Crossing Status: Found UCIP Comments: No permit identified for this crossing. FIELD_STRUCT_DESC: 1.5-inch polyvinyl chloride (PVC) irrigation pipe through the levee, 2 feet below the crown. Pump at the landside (LS) toe. Vent on the waterside (WS) shoulder. This crossing was field discovered. FS Date: 2/13/2014

Pipe and vent visible next to wooden walkway on WS shoulder.

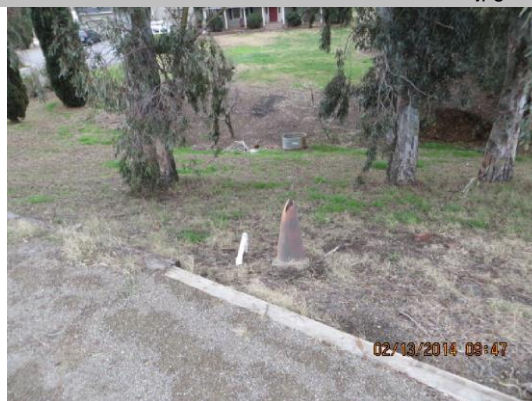
Photo 2 of 3 : UCIP\_FA\_2018\_31286\_57294.jpg

LM Start	5.10	Rating **	M	Issue No.	200 (cont)	
LM End	5.10	Issue Type +	En	Location *		
Category	Supplemental			GPS Latitude/Longitude		
				Start	End	
Item	DWR UCIP Field Study			38.242649 °	38.242649 °	
				-121.600854 °	-121.600854 °	
DWR ID	24837					
Comment Code						
Inspector Comment						
FS_ID:31286 DS_ID:24837 EP_NO: N/A Repair Type: Non-Urgent Crossing Status: Found UCIP Comments: No permit identified for this crossing. FIELD_STRUCT_DESC: 1.5-inch polyvinyl chloride (PVC) irrigation pipe through the levee, 2 feet below the crown. Pump at the landside (LS) toe. Vent on the waterside (WS) shoulder. This crossing was field discovered. FS Date: 2/13/2014

Pipe visible on LS shoulder with pump visible at LS toe in background.

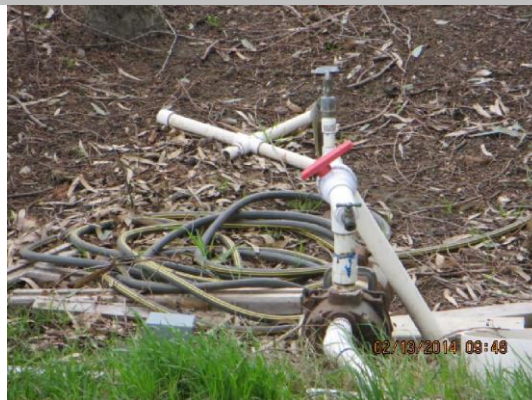
Photo 3 of 3 : UCIP\_FA\_2018\_31286\_57293.jpg

Pump and shutoff valve visible at LS toe.

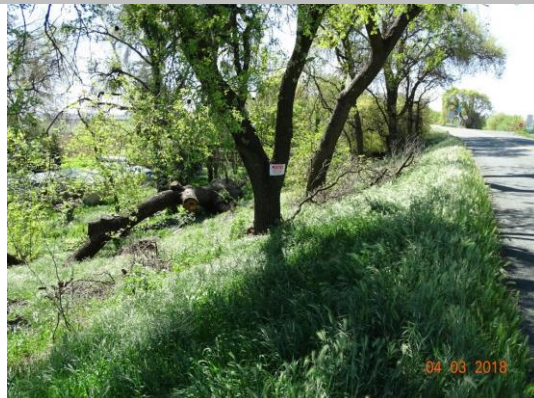
Photo 1 of 1 : FA\_2018\_RD0003\_24\_58\_20180925\_00042.jpg

LM Start	5.46	Rating **	U	Issue No.	58
LM End	5.46	Issue Type +	En	Location *	LS
Category	Earthen Levee			GPS Latitude/Longitude	
				Start	End
Item	Encroachments			38.237515 °	38.237515 °
				-121.602225 °	-121.602225 °
DWR ID	DWR_RD0003_01_s_2017_58				
Comment Code					
TR : Tree or limb					
Inspector Comment					
Downed tree with large root ball on landward slope is being cut up and should be removed.

Removal of large fallen tree should continue.

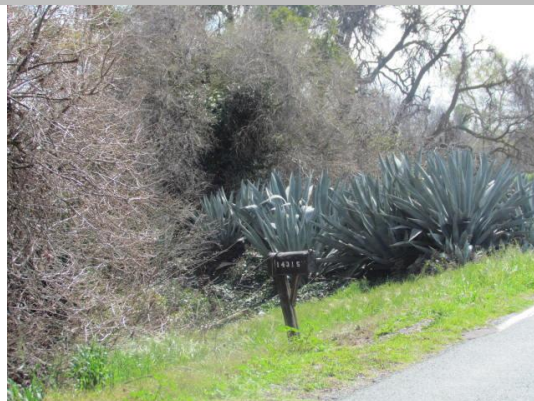
Photo 1 of 1 : FA\_2018\_RD0003\_24\_44\_20180925\_00030.jpg

LM Start	5.49	Rating **	U	Issue No.	44
LM End	5.49	Issue Type +	En	Location *	LS
Category	Earthen Levee			GPS Latitude/Longitude	
				Start	End
Item	Vegetation			38.236994 °	38.236994 °
				-121.602278 °	-121.602278 °
DWR ID	DWR_RD0003_01_s_2012_44				
Comment Code					
V6 : Landscaping					
Inspector Comment					
Large century plants.

Looking southeast at century plants on landside shoulder and slope.

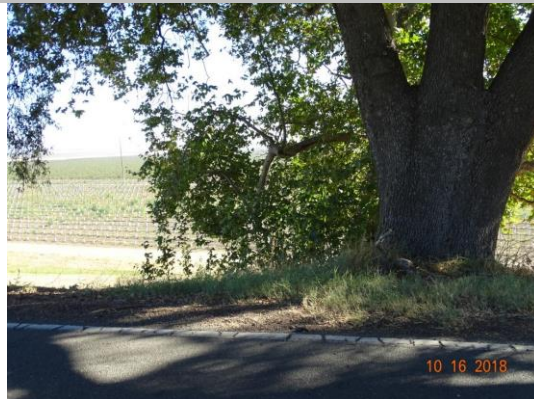
Photo 1 of 2 : FA\_2018\_RD0003\_24\_63\_20181017\_00163.jpg

LM Start	5.65	Rating **	M	Issue No.	63
LM End	5.65	Issue Type +	Ma	Location *	LS
Category	Earthen Levee			GPS Latitude/Longitude	
				Start	End
Item	Trim / Thin Trees			38.234721 °	38.234721 °
				-121.601709 °	-121.601709 °
DWR ID	DWR_RD0003_01_f_2016_63				
Comment Code					
T1 : Trim trees to at least five feet above ground level.					
Inspector Comment					
Trim growth from tree so that levee slope can be seen.

View of slope where tree limb was removed. Now the extra growth on the existing branches needs to be removed (October 2018).

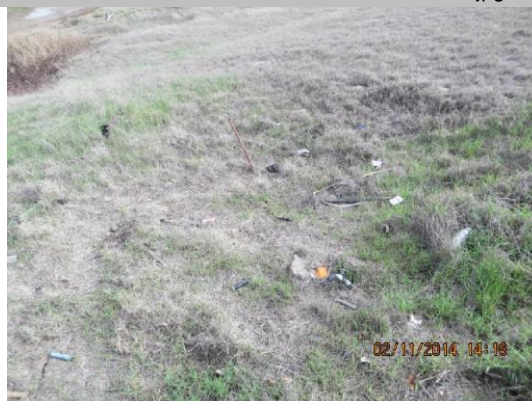
Photo 1 of 3 : UCIP\_FA\_2018\_29823\_55105.jpg

Comment Code						
Inspector Comment						
FS_ID:29823						
DS_ID:22171						
EP_NO: N/A						
Repair Type: Non-Urgent						
Crossing Status: Found						
UCIP Comments: Pipe appears abandoned or in disrepair at siphon/vent on LS shoulder.						
FIELD_STRUCT_DESC: 12-inch steel irrigation siphon through the levee, invert elevation 4 feet below the crown. Pipe discharges into a large hole at the landside (LS) toe which is connected to irrigation ditches. Siphon and vent visible on the landside (LS) shoulder. (USACE Unit No. 10, new pipe in 1966 - W. Beck). [Additional Reference(s): DWR Levee Log, 1993. USACE Sacramento O&M Manual 104, February 1960, (RM 20.13)].						
FS Date: 2/11/2014

Siphon and vent on LS shoulder.

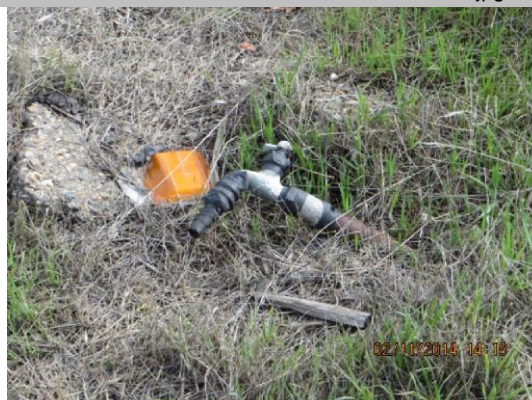
Photo 2 of 3 : UCIP\_FA\_2018\_29823\_55104.jpg

Vent on LS shoulder.

Comment Code						
Inspector Comment						
FS_ID:29823						
DS_ID:22171						
EP_NO: N/A						
Repair Type: Non-Urgent						
Crossing Status: Found						
UCIP Comments: Pipe appears abandoned or in disrepair at siphon/vent on LS shoulder.						
FIELD_STRUCT_DESC: 12-inch steel irrigation siphon through the levee, invert elevation 4 feet below the crown. Pipe discharges into a large hole at the landside (LS) toe which is connected to irrigation ditches. Siphon and vent visible on the landside (LS) shoulder. (USACE Unit No. 10, new pipe in 1966 - W. Beck). [Additional Reference(s): DWR Levee Log, 1993. USACE Sacramento O&M Manual 104, February 1960, (RM 20.13)].						
FS Date: 2/11/2014

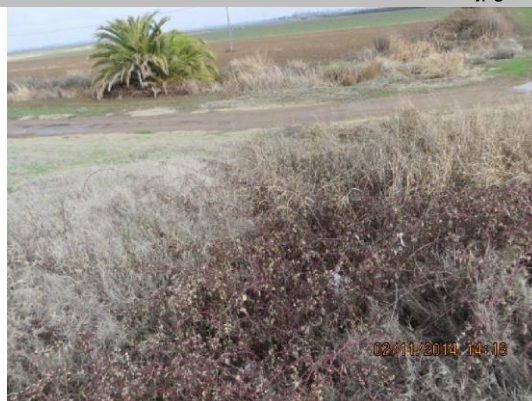
Photo 3 of 3 : UCIP\_FA\_2018\_29823\_55103.jpg

Irrigation ditch filled with berries on LS toe.

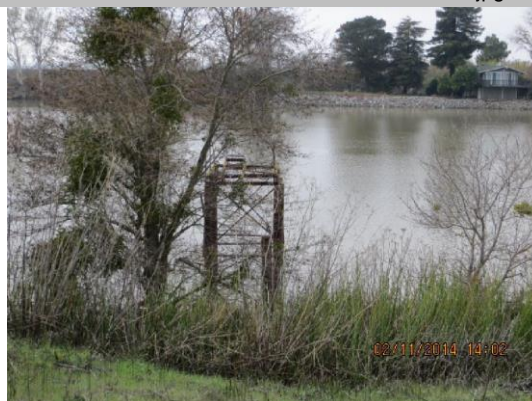
Photo 1 of 3 : UCIP\_FA\_2018\_29403\_54462.jpg

Comment Code						
Inspector Comment						
FS_ID:29403						
DS_ID:22173						
EP_NO: 1392						
Repair Type: Non-Urgent						
Crossing Status: Found						
UCIP Comments: Pipe abandoned and should be done so properly.						
FIELD_STRUCT_DESC: *ABANDONED* 18-inch steel irrigation						
discharge pipe through the levee, invert elevation 4.5 feet below the						
crown. Pump removed from the pile structure in the slough. Concrete						
standpipe on the landside (LS) toe. Concrete plug on the waterside						
(WS) end. (Plans for installing a vertical unit irrigation pumping plant						
with an 18-inch steel pipe through the levee authorized under Permit						
No. 1392, 1949 - Ednora Stefani). [Additional Reference(s): DWR						
Levee Log, 1993. USACE Sacramento O&M Manual 104, February						
1960, (RM 19.83)].						
FS Date: 2/11/2014

Steel pier on WS toe, pipe visible on ground directly in front of pier on slope.

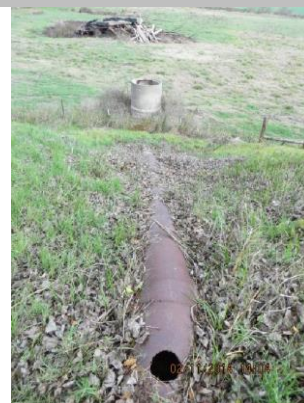
Photo 3 of 3 : UCIP\_FA\_2018\_29403\_54460.jpg

Comment Code						
Inspector Comment						
FS_ID:29403 DS_ID:22173 EP_NO: 1392 Repair Type: Non-Urgent Crossing Status: Found UCIP Comments: Pipe abandoned and should be done so properly. FIELD_STRUCT_DESC: *ABANDONED* 18-inch steel irrigation discharge pipe through the levee, invert elevation 4.5 feet below the crown. Pump removed from the pile structure in the slough. Concrete standpipe on the landside (LS) toe. Concrete plug on the waterside (WS) end. (Plans for installing a vertical unit irrigation pumping plant with an 18-inch steel pipe through the levee authorized under Permit No. 1392, 1949 - Ednora Stefani). [Additional Reference(s): DWR Levee Log, 1993. USACE Sacramento O&M Manual 104, February 1960, (RM 19.83)]. FS Date: 2/11/2014

Pipe and concrete standpipe on LS slope.

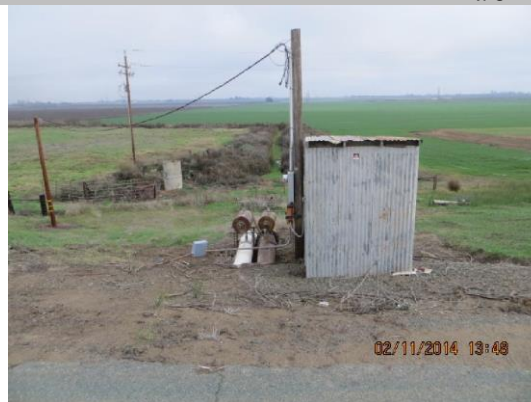
Photo 1 of 3 : UCIP\_FA\_2018\_29266\_54159.jpg

Comment Code						
Inspector Comment						
FS_ID:29266						
DS_ID:22175						
EP_NO: N/A						
Repair Type: Non-Urgent						
Crossing Status: Found						
UCIP Comments: Hole in pipe on WS slope may need to be sealed depending on nature of sliplined pipe.						
FIELD_STRUCT_DESC: 1 of 2: 18-inch steel irrigation siphon through the levee, invert elevation 7 feet below the crown. Primer pump in a pump house on the landside (LS) slope. Pipe has been slip lined with a high-density polyethylene (HDPE) liner. Polyvinyl chloride (PVC) pipe may be attached to the steel pipe on the LS shoulder. [Additional Reference(s): DWR Levee Log, 1993. USACE Sacramento O&M Manual 104, February 1960, (RM 19.77)].						
FS Date: 2/11/2014

Pipe visible next to pumphouse on LS shoulder.

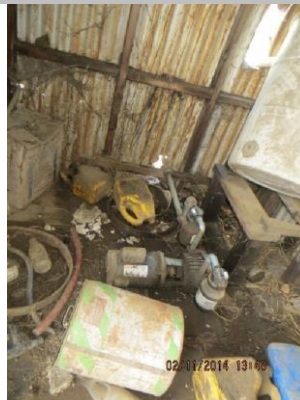
Photo 2 of 3 : UCIP\_FA\_2018\_29266\_54158.jpg

Comment Code						
Inspector Comment						
FS_ID:29266						
DS_ID:22175						
EP_NO: N/A						
Repair Type: Non-Urgent						
Crossing Status: Found						
UCIP Comments: Hole in pipe on WS slope may need to be sealed depending on nature of sliplined pipe.						
FIELD_STRUCT_DESC: 1 of 2: 18-inch steel irrigation siphon through the levee, invert elevation 7 feet below the crown. Primer pump in a pump house on the landside (LS) slope. Pipe has been slip lined with a high-density polyethylene (HDPE) liner. Polyvinyl chloride (PVC) pipe may be attached to the steel pipe on the LS shoulder. [Additional Reference(s): DWR Levee Log, 1993. USACE Sacramento O&M Manual 104, February 1960, (RM 19.77)].						
FS Date: 2/11/2014

Pump in pumphouse on LS shoulder.

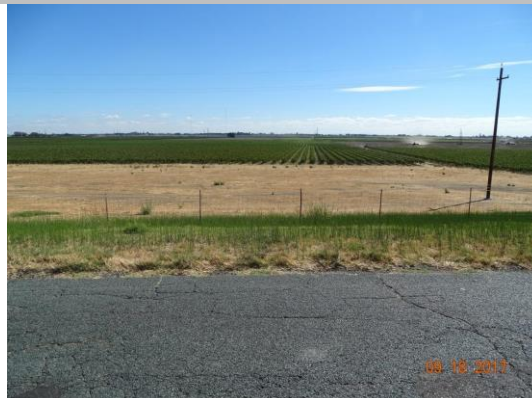
Photo 1 of 1 : FA\_2018\_RD0003\_24\_84\_20180925\_00072.jpg

LM Start	6.32	Rating **	M	Issue No.	84
LM End	6.62	Issue Type +	En	Location *	LS
Category	Earthen Levee			GPS Latitude/Longitude	
				Start	End
Item	Encroachments			38.225176 °	38.220769 °
				-121.601329 °	-121.601105 °
DWR ID	DWR_RD0003_01_f_2017_84				
Comment Code					
FE : Fence					
Inspector Comment					
Fence on landside slope.

Looking east at fence at landside toe.

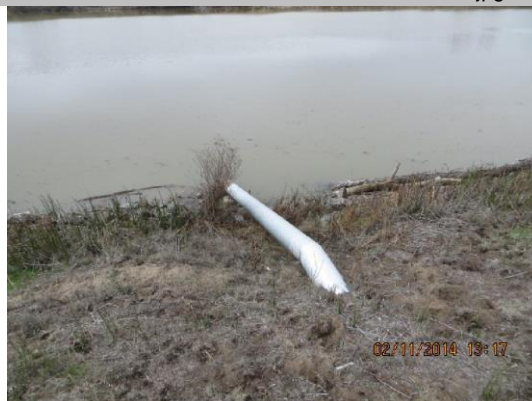
Photo 1 of 3 : UCIP\_FA\_2018\_29258\_54138.jpg

Comment Code						
Inspector Comment						
FS_ID:29258 DS_ID:22179 EP_NO: 853 Repair Type: Non-Urgent Crossing Status: Found UCIP Comments: Siphon breaker/vent needs proper installation/riser. FIELD_STRUCT_DESC: 12-inch steel irrigation siphon through the levee, invert elevation 4 feet below the crown. Siphon breaker on the landside (LS) shoulder. 36-inch concrete standpipe on the LS toe. (Plans for the installation of a 6-inch horizontal bolted centrifugal pump together with an 8-inch, 10-gauge welded steel pipe through the levee authorized under Permit No. 853, 1941 - Louis A. Bixler. Plans for installing a 12-inch steel irrigation siphon through the levee authorized under Permit No. 1462, 1950 - Vic Romanini. USACE Unit No. 10, new pipe installed in 1967). [Additional Reference(s): DWR Levee Log, 1993. USACE Sacramento O&M Manual 104, February 1960, (RM 19.20)]. FS Date: 2/11/2014

Pipe visible on WS slope.

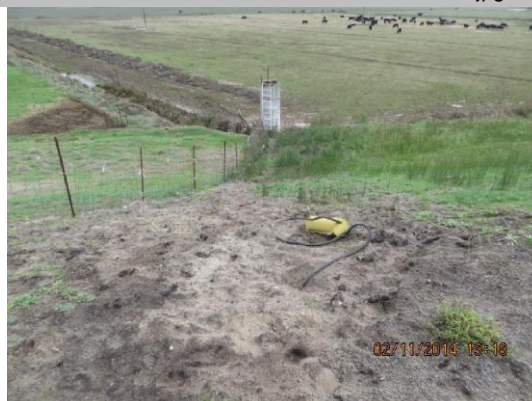
Photo 2 of 3 : UCIP\_FA\_2018\_29258\_54137.jpg

Comment Code						
Inspector Comment						
FS_ID:29258 DS_ID:22179 EP_NO: 853 Repair Type: Non-Urgent Crossing Status: Found UCIP Comments: Siphon breaker/vent needs proper installation/riser. FIELD_STRUCT_DESC: 12-inch steel irrigation siphon through the levee, invert elevation 4 feet below the crown. Siphon breaker on the landside (LS) shoulder. 36-inch concrete standpipe on the LS toe. (Plans for the installation of a 6-inch horizontal bolted centrifugal pump together with an 8-inch, 10-gauge welded steel pipe through the levee authorized under Permit No. 853, 1941 - Louis A. Bixler. Plans for installing a 12-inch steel irrigation siphon through the levee authorized under Permit No. 1462, 1950 - Vic Romanini. USACE Unit No. 10, new pipe installed in 1967). [Additional Reference(s): DWR Levee Log, 1993. USACE Sacramento O&M Manual 104, February 1960, (RM 19.20)]. FS Date: 2/11/2014

Siphon breaker/vent visible on LS slope with concrete standpipe visible in background at toe.

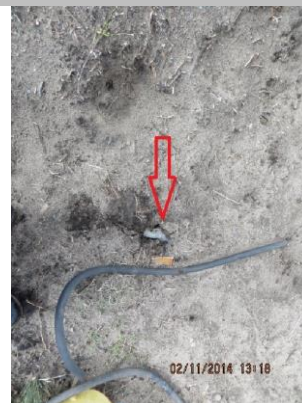
Photo 3 of 3 : UCIP\_FA\_2018\_29258\_54136.jpg

Siphon breaker/vent visible on LS slope.

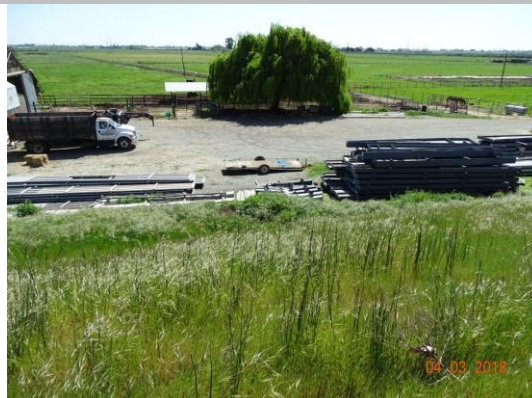
Photo 1 of 1 : FA\_2018\_RD0003\_24\_87\_20180925\_00074.jpg

LM Start	6.95	Rating **	U	Issue No.	87
LM End	6.95	Issue Type +	En	Location *	LS
Category	Earthen Levee			GPS Latitude/Longitude	
				Start	End
Item	Encroachments			38.216609 °	38.216609 °
				-121.603999 °	-121.603999 °
DWR ID	DWR_RD0003_01_s_2018_87				
Comment Code					
EQ : Equipment					
Inspector Comment

Equipment stockpiled at landside toe.

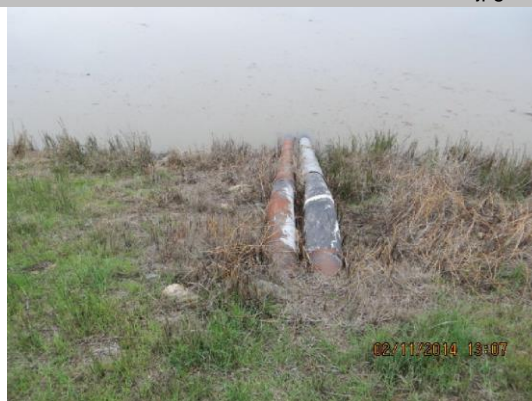
Photo 1 of 3 : UCIP\_FA\_2018\_50428\_54124.jpg

Comment Code					
Inspector Comment					
FS_ID:50428 DS_ID:22346 EP_NO: N/A Repair Type: Non-Urgent Crossing Status: Found UCIP Comments: 07/06/2016 Same as last inspection. Annular space needs to be grouted per Title 23. This crossing has been downgraded from Urgent to Non-Urgent because the hole created in the conduit sleeve was deliberate and not a sign of pipe failure. Pipe was flowing at the time of the inspection (possibly via a portable pump). (DWR UCIP - K. Fazel)02/11/2014 Pipe cut open on LS shoulder and along slope. 3.5-inch PVC pipe sleeved through with 2 vents with valves. Pipe annular space not grouted. (DWR FPIIB - G. Wylie) FIELD_STRUCT_DESC: 1 of 2: 12-inch steel irrigation siphon through the levee, invert elevation 3 feet below the crown. Siphon breaker on the landside (LS) shoulder. 3.5-inch polyvinyl chloride (PVC) pipe sleeved through the existing 12-inch pipe. (Vic Romanini). [Additional Reference(s): DWR Levee Log, 1993. USACE Sacramento O&M Manual 104, February 1960, (RM 19.06)]. FS Date: 7/6/2016

Steel pipe visible on WS slope

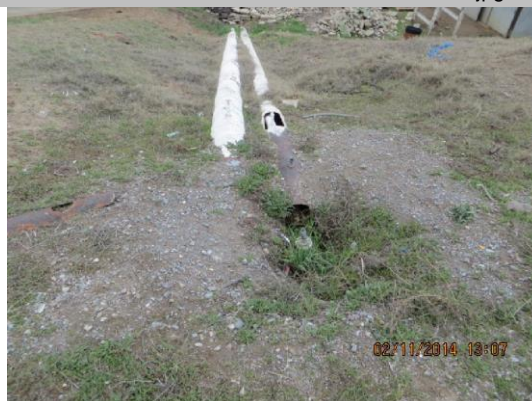
Photo 2 of 3 : UCIP\_FA\_2018\_50428\_54123.jpg

FS\_ID:50428  
DS\_ID:22346  
EP\_NO: N/A  
Repair Type: Non-Urgent  
Crossing Status: Found  
UCIP Comments: 07/06/2016 Same as last inspection. Annular space needs to be grouted per Title 23. This crossing has been downgraded from Urgent to Non-Urgent because the hole created in the conduit sleeve was deliberate and not a sign of pipe failure. Pipe was flowing at the time of the inspection (possibly via a portable pump). (DWR UCIP - K. Fazel)02/11/2014 Pipe cut open on LS shoulder and along slope. 3.5-inch PVC pipe sleeved through with 2 vents with valves. Pipe annular space not grouted. (DWR FPIIB - G. Wylie)  
FIELD\_STRUCT\_DESC: 1 of 2: 12-inch steel irrigation siphon through the levee, invert elevation 3 feet below the crown. Siphon breaker on the landside (LS) shoulder. 3.5-inch polyvinyl chloride (PVC) pipe sleeved through the existing 12-inch pipe. (Vic Romanini). [Additional Reference(s): DWR Levee Log, 1993. USACE Sacramento O&M Manual 104, February 1960, (RM 19.06)].

Pipe visible on LS slope with cuts at two places.

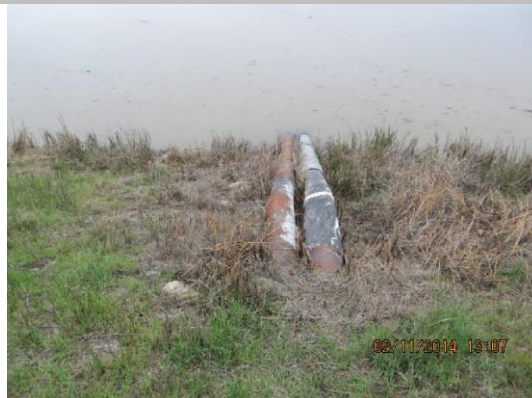
Photo 1 of 3 : UCIP\_FA\_2018\_50427\_54133.jpg

FS\_ID:50427  
DS\_ID:22180  
EP\_NO: N/A  
Repair Type: Non-Urgent  
Crossing Status: Found  
UCIP Comments: 07/06/2016 Same as last inspection. Annular space needs to be grouted per Title 23. This crossing has been downgraded from Urgent to Non-Urgent because the deformed nature of the pipe is not indicative of imminent failure. (DWR UCIP - K. Fazel)02/11/2014 Pipe sleeved with a PVC pipe that is crushed on the WS slope. Annular space not grouted. (DWR FPIIB - G. Wylie)  
FIELD\_STRUCT\_DESC: 2 of 2: 14-inch steel irrigation siphon through the levee, invert elevation 3.1 feet below the crown. Siphon breaker on the landside (LS) shoulder. 14-inch pipe sleeved with a smaller diameter polyvinyl chloride (PVC) pipe. (Vic Romanini). [Additional Reference(s): DWR Levee Log, 1993, referenced as 3 feet below the crown. USACE Sacramento O&M Manual 104, February 1960, (RM 19.06)].  
FS Date: 7/6/2016

Pipe visible on WS slope, PVC pipe exposed and crushed on WS slope.

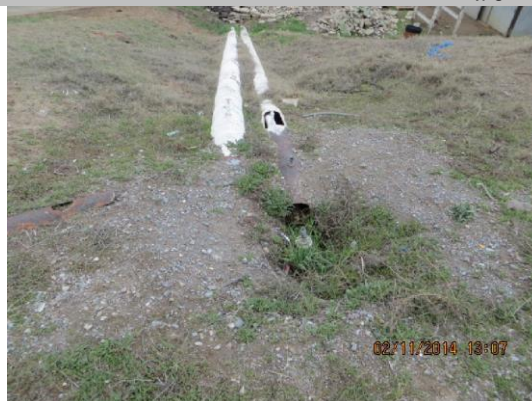
Photo 2 of 3 : UCIP\_FA\_2018\_50427\_54132.jpg

PVC pipe visible on LS slope.

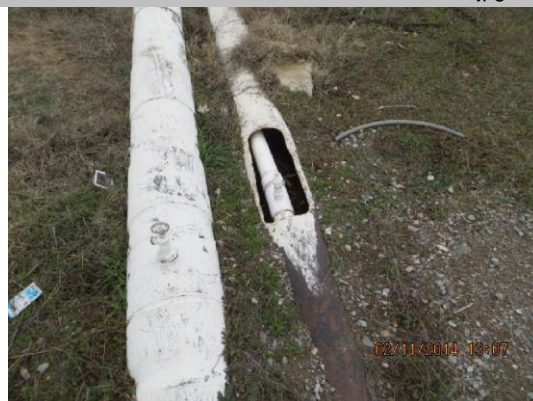
Photo 3 of 3 : UCIP\_FA\_2018\_50427\_54131.jpg

Comment Code						
Inspector Comment						
FS_ID:50427 DS_ID:22180 EP_NO: N/A Repair Type: Non-Urgent Crossing Status: Found UCIP Comments: 07/06/2016 Same as last inspection. Annular space needs to be grouted per Title 23. This crossing has been downgraded from Urgent to Non-Urgent because the deformed nature of the pipe is not indicative of imminent failure. (DWR UCIP - K. Fazel)02/11/2014 Pipe sleeved with a PVC pipe that is crushed on the WS slope. Annular space not grouted. (DWR FPIIB - G. Wylie) FIELD_STRUCT_DESC: 2 of 2: 14-inch steel irrigation siphon through the levee, invert elevation 3.1 feet below the crown. Siphon breaker on the landside (LS) shoulder. 14-inch pipe sleeved with a smaller diameter polyvinyl chloride (PVC) pipe. (Vic Romanini). [Additional Reference(s): DWR Levee Log, 1993, referenced as 3 feet below the crown. USACE Sacramento O&M Manual 104, February 1960, (RM 19.06)]. FS Date: 7/6/2016

Siphon breaker on PVC pipe on LS slope.

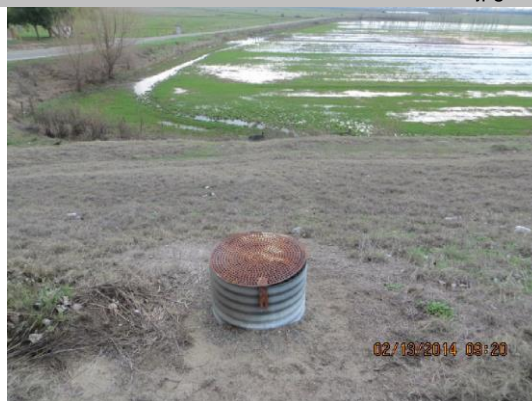
Photo 1 of 2 : UCIP\_FA\_2018\_29924\_55248.jpg

LM Start	7.10	Rating **	M	Issue No.	207
LM End	7.10	Issue Type +	En	Location *	
Category	Supplemental			GPS Latitude/Longitude	
				Start	End
Item	DWR UCIP Field Study			38.214684 °	38.214684 °
				-121.605242 °	-121.605242 °
DWR ID	22181				
Comment Code					
Inspector Comment					
FS_ID:29924 DS_ID:22181 EP_NO: N/A Repair Type: Non-Urgent Crossing Status: Found UCIP Comments: Pipe appears abandoned and should be verified as having been done so properly. FIELD_STRUCT_DESC: 12-inch steel irrigation siphon through the levee, invert elevation 3 feet below the crown. Siphon breaker in a 24-inch corrugated metal pipe (CMP) riser on the landside (LS) shoulder. 4-foot concrete standpipe at the LS toe. (Vic Romanini). [Additional Reference(s): DWR Levee Log, 1993. USACE Sacramento O&M Manual 104, February 1960, (RM 18.89)]. FS Date: 2/11/2014

Siphon breaker in CMP riser on LS shoulder.

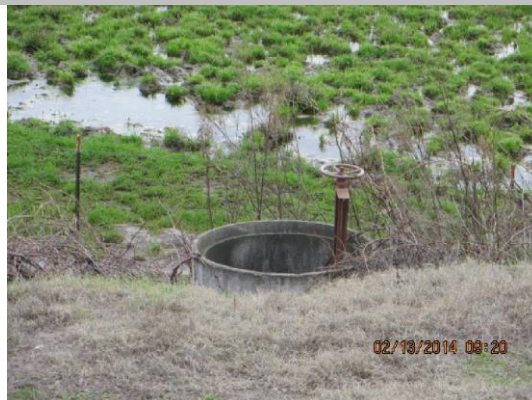
Photo 2 of 2 : UCIP\_FA\_2018\_29924\_55247.jpg

Concrete standpipe on LS toe.

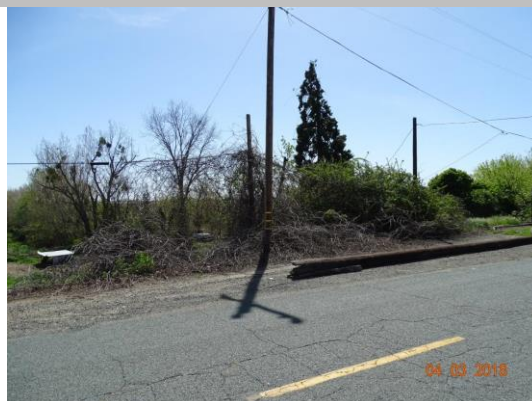
Photo 1 of 1 : FA\_2018\_RD0003\_24\_90\_20180925\_00075.jpg

LM Start	7.61	Rating **	U	Issue No.	90
LM End	7.63	Issue Type +	En	Location *	LS
Category	Earthen Levee			GPS Latitude/Longitude	
				Start	End
Item	Vegetation			38.208017 °	38.207700 °
				-121.609185 °	-121.609342 °
DWR ID	DWR_RD0003_01_s_2018_90				
Comment Code					
V6 : Landscaping					
Inspector Comment

Landside landscaping inhibits inspection and access.

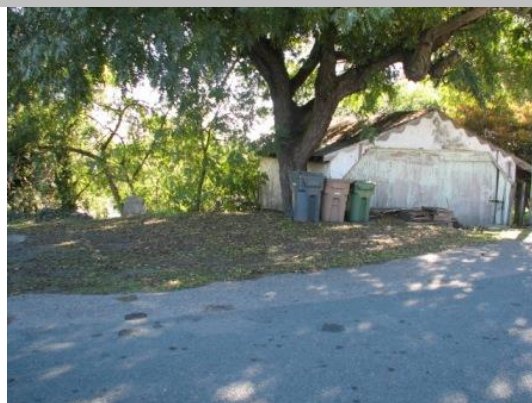
Photo 1 of 1 : FA\_2018\_RD0003\_24\_74\_20180925\_00062.jpg

LM Start	7.63	Rating **	U	Issue No.	74
LM End	7.63	Issue Type +	En	Location *	LS
Category	Earthen Levee			GPS Latitude/Longitude	
				Start	End
Item	Encroachments			38.207666 °	38.207666 °
				-121.609327 °	-121.609327 °
DWR ID	DWR_RD0003_01_s_2012_74				
Comment Code					
BU : Building					
Inspector Comment

Buildings obstruct access and visibility of levee slope and toe.

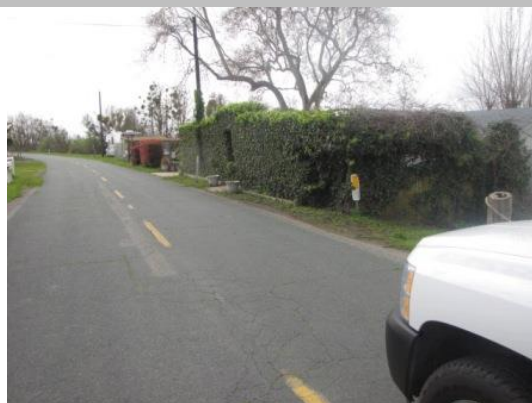
Photo 1 of 1 : FA\_2018\_RD0003\_24\_75\_20180925\_00063.jpg

LM Start	7.64	Rating **	U	Issue No.	75
LM End	7.64	Issue Type +	En	Location *	WS
Category	Earthen Levee			GPS Latitude/Longitude	
				Start	End
Item	Vegetation			38.207640°	38.207640°
				-121.609334°	-121.609334°
DWR ID	DWR_RD0003_01_s_2012_75				
Comment Code					
V6 : Landscaping					
Inspector Comment

Looking southwest at landscaping in front of a house on waterside berm.  
Also not in the picture a building on landside berm.

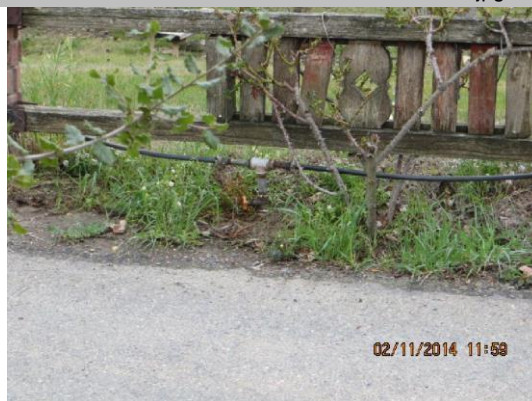
Photo 1 of 3 : UCIP\_FA\_2018\_31283\_57282.jpg

FS\_ID:31283  
DS\_ID:24836  
EP\_NO: N/A  
Repair Type: Non-Urgent  
Crossing Status: Found  
UCIP Comments: No permit identified for this crossing.  
FIELD\_STRUCT\_DESC: 2.5-inch galvanized iron irrigation pipe through the levee, at an unknown depth. Pipe and spigot visible at the waterside (WS) toe. A second spigot on the landside (LS) slope. This crossing was field discovered.  
FS Date: 2/11/2014

Shutoff valve next to LS ramp

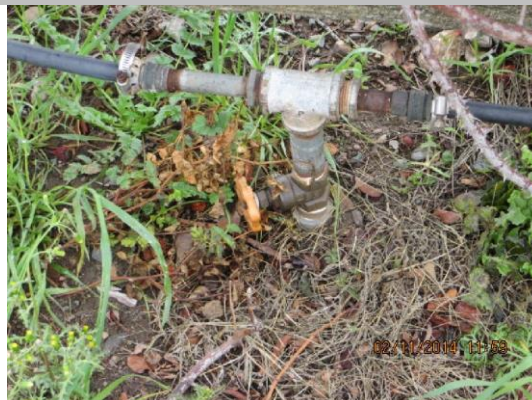
Photo 2 of 3 : UCIP\_FA\_2018\_31283\_57281.jpg

Shutoff valve next to LS ramp

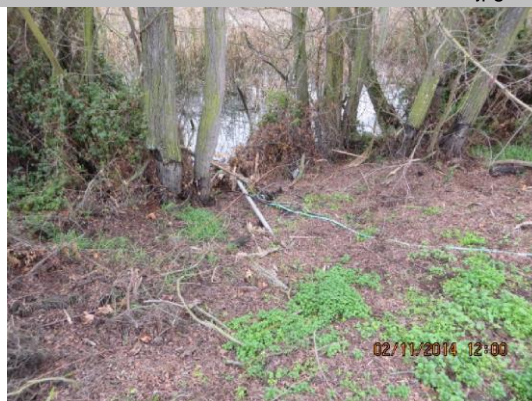
Photo 3 of 3 : UCIP\_FA\_2018\_31283\_57280.jpg

LM Start	7.76	Rating **	M	Issue No.	208 (cont)	
LM End	7.76	Issue Type +	En	Location *		
Category	Supplemental			GPS Latitude/Longitude		
				Start	End	
Item	DWR UCIP Field Study			38.205846°	38.205846°	
				-121.609574°	-121.609574°	
DWR ID	24836					
Comment Code						
Inspector Comment						
FS_ID:31283 DS_ID:24836 EP_NO: N/A Repair Type: Non-Urgent Crossing Status: Found UCIP Comments: No permit identified for this crossing. FIELD_STRUCT_DESC: 2.5-inch galvanized iron irrigation pipe through the levee, at an unknown depth. Pipe and spigot visible at the waterside (WS) toe. A second spigot on the landside (LS) slope. This crossing was field discovered. FS Date: 2/11/2014

Pipe visible at WS toe.

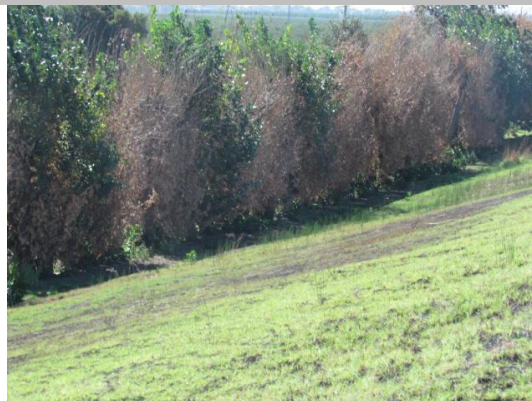
Photo 1 of 3 : FA\_2018\_RD0003\_24\_78\_20180925\_00065.jpg

LM Start	7.80	Rating **	U	Issue No.	78
LM End	8.25	Issue Type +	En	Location *	LS
Category	Earthen Levee			GPS Latitude/Longitude	
				Start	End
Item	Encroachments			38.205243 °	38.198989 °
				-121.609689 °	-121.611815 °
DWR ID	DWR_RD0003_01_s_2012_78				
Comment Code					
TR : Tree or limb					
Inspector Comment					
Trees within 10' of levee toe obstruct access and visibility of levee toe.

Looking eastly at trees blocking view of landward toe. (Fall 2015)

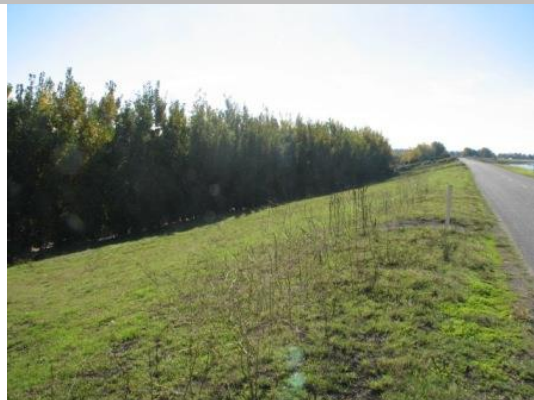
Photo 2 of 3 : FA\_2018\_RD0003\_24\_78\_20180925\_00066.jpg

Trees within 10' of levee toe obstruct access and visibility of levee toe.  
(Fall 2014)

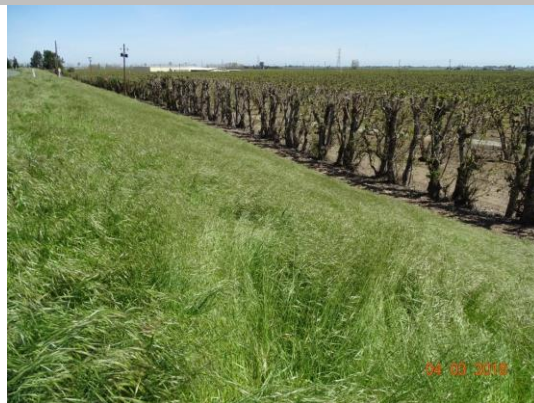
Photo 3 of 3 : FA\_2018\_RD0003\_24\_78\_20180925\_00067.jpg

Closely spaced trees along toe.

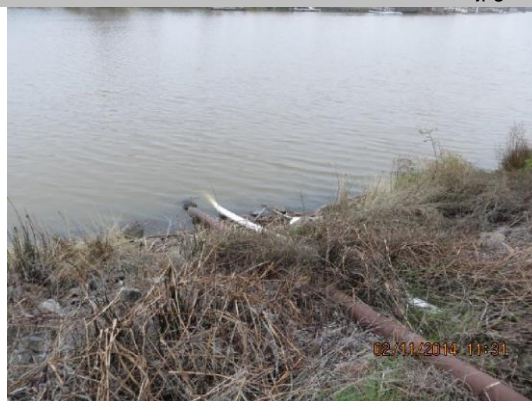
Photo 1 of 3 : UCIP\_FA\_2018\_29235\_54053.jpg

Comment Code						
Inspector Comment						
FS_ID:29235 DS_ID:22186 EP_NO: 2225 Repair Type: Non-Urgent Crossing Status: Found UCIP Comments: CMP riser knocked over and no sign of siphon breaker. FIELD_STRUCT_DESC: 8-inch steel irrigation discharge pipe through the levee, invert elevation 3.5 feet below the crown. Service pole and siphon breaker in a corrugated metal pipe (CMP) riser on the landside (LS) slope. Pump in a pump house and a booster pump on a concrete slab on the waterside (WS) slope. (Plans to install an 8-inch irrigation pipe through the levee and an inclined pump on the WS slope authorized under Permit No. 2225, 1955 - Fay Ranch, Captain N. A. Fay, care of The River Lines, Inc. USACE Unit No. 10, new pipe installed in 1967). [Additional Reference(s): DWR Levee Log, 1993. USACE Sacramento O&M Manual 104, February 1960, (17.92)]. FS Date: 2/11/2014

Pipe visible on WS toe.

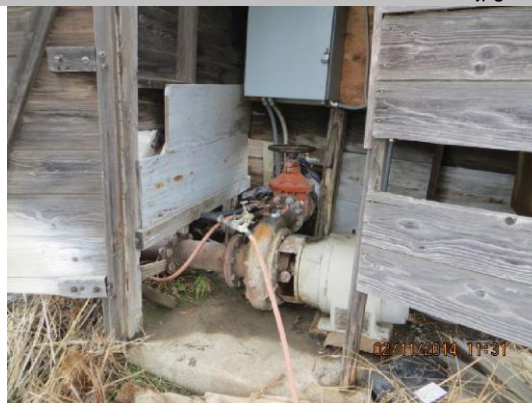
Photo 2 of 3 : UCIP\_FA\_2018\_29235\_54052.jpg

Pump and gate valve visible inside pumphouse on WS shoulder.

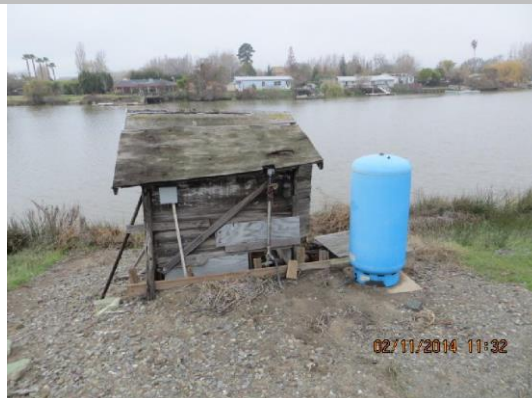
Photo 3 of 3 : UCIP\_FA\_2018\_29235\_54051.jpg

Pump and tank on WS shoulder.

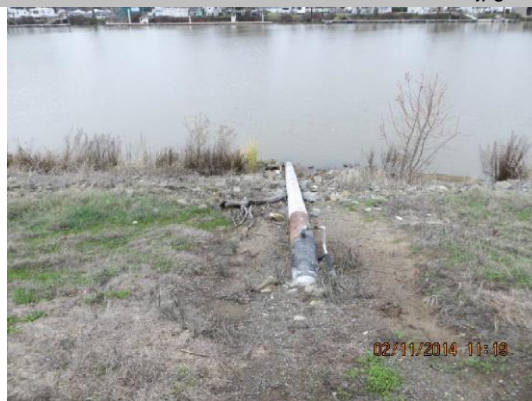
Photo 1 of 3 : UCIP\_FA\_2018\_29233\_54047.jpg

Comment Code						
Inspector Comment						
FS_ID:29233						
DS_ID:22187						
EP_NO: N/A						
Repair Type: Non-Urgent						
Crossing Status: Found						
UCIP Comments: Siphon breaker and CMP riser missing from LS slope.						
FIELD_STRUCT_DESC: 12-inch steel irrigation siphon through the						
levee, invert elevation 3.5 feet below the crown. Primer pump in a pump						
house and a siphon breaker in a corrugated metal pipe (CMP) riser on						
the landside (LS) slope. 48-inch concrete standpipe at the LS toe.						
(USACE Unit No. 10, new pipe installed in 1967). [Additional						
Reference(s): DWR Levee Log, 1993. USACE Sacramento O&M						
Manual 104, February 1960, (RM 17.79)].						
FS Date: 2/11/2014

Pipe visible on WS slope.

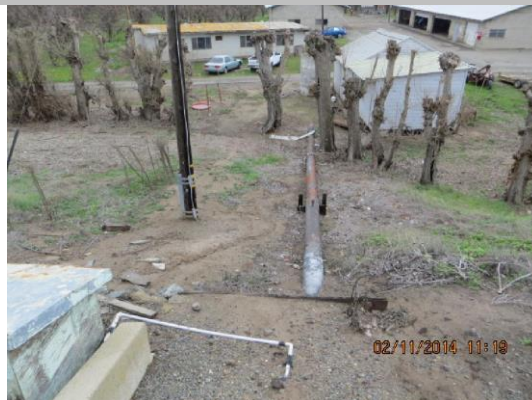
Photo 2 of 3 : UCIP\_FA\_2018\_29233\_54046.jpg

Pipe, pumphouse, and standpipe visible on LS slope.

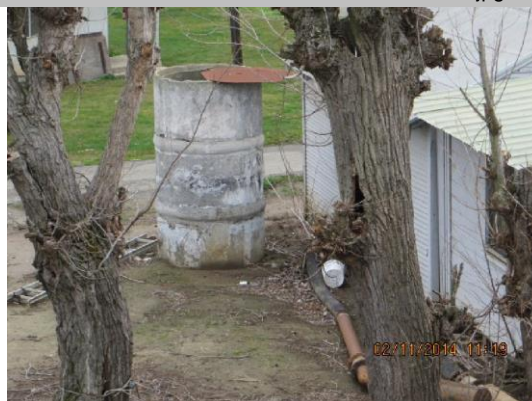
Photo 3 of 3 : UCIP\_FA\_2018\_29233\_54045.jpg

Concrete standpipe on LS toe.

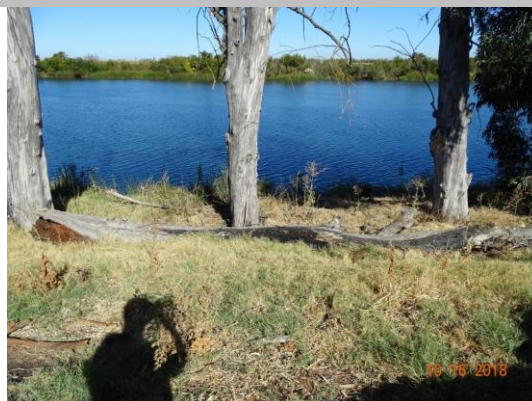
Photo 1 of 1 : FA\_2018\_RD0003\_24\_100\_20181018\_00166.jpg

LM Start	8.77	Rating **	M	Issue No.	100
LM End	8.77	Issue Type +	En	Location *	WS
Category	Earthen Levee			GPS Latitude/Longitude	
				Start	End
Item	Encroachments			38.193813 °	38.193813 °
				-121.618135 °	-121.618135 °
DWR ID	DWR_RD0003_01_f_2018_100				
Comment Code					
TR : Tree or limb					
Inspector Comment					
Remove tree on water side slope.

View of down tree on water side slope (October 2018).

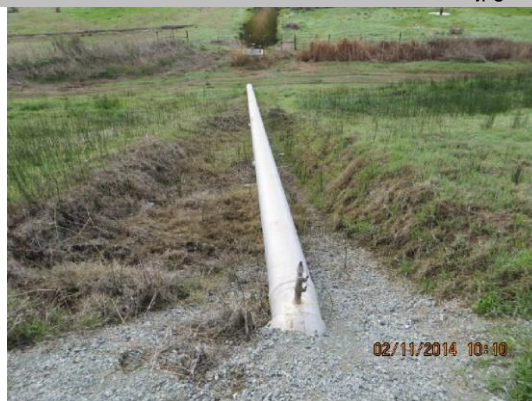
Photo 1 of 3 : UCIP\_FA\_2018\_29187\_53952.jpg

Comment Code						
Inspector Comment						
FS_ID:29187						
DS_ID:22202						
EP_NO: N/A						
Repair Type: Non-Urgent						
Crossing Status: Found						
UCIP Comments: Annular space between 12 and 14-inch pipes not grouted.						
FIELD_STRUCT_DESC: 14-inch steel irrigation siphon through the levee, invert elevation 2.9 feet below the crown. 14-inch pipe sleeved with a 12-inch pipe. Vent and siphon breaker on the landside (LS) shoulder. Concrete distribution box and gate valve at the LS toe. [Additional Reference(s): DWR Levee Log, 1993, referenced as a 16-inch pipe sleeved with a 12-inch pipe. USACE Sacramento O&M Manual 104, February 1960, (RM 16.92), referenced as a 16-inch pipe sleeved with a 14-inch pipe].						
FS Date: 2/11/2014 11:00:22 AM

Pipe, siphon breaker/vent, and distribution box visible on LS.

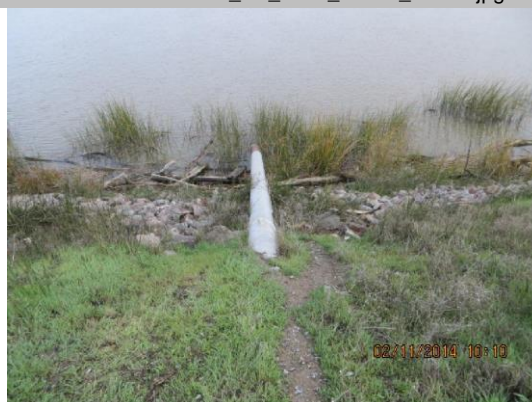
Photo 2 of 3 : UCIP\_FA\_2018\_29187\_53951.jpg

Pipe visible on WS slope.

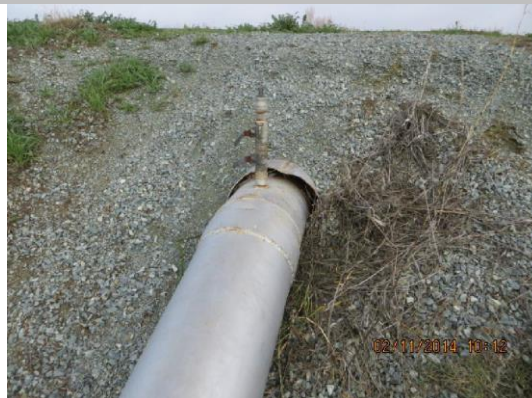
Photo 3 of 3 : UCIP\_FA\_2018\_29187\_53950.jpg

Comment Code						
Inspector Comment						
FS_ID:29187 DS_ID:22202 EP_NO: N/A Repair Type: Non-Urgent Crossing Status: Found UCIP Comments: Annular space between 12 and 14-inch pipes not grouted. FIELD_STRUCT_DESC: 14-inch steel irrigation siphon through the levee, invert elevation 2.9 feet below the crown. 14-inch pipe sleeved with a 12-inch pipe. Vent and siphon breaker on the landside (LS) shoulder. Concrete distribution box and gate valve at the LS toe. [Additional Reference(s): DWR Levee Log, 1993, referenced as a 16-inch pipe sleeved with a 12-inch pipe. USACE Sacramento O&M Manual 104, February 1960, (RM 16.92), referenced as a 16-inch pipe sleeved with a 14-inch pipe]. FS Date: 2/11/2014 11:00:22 AM

Annular space not grouted between pipes.

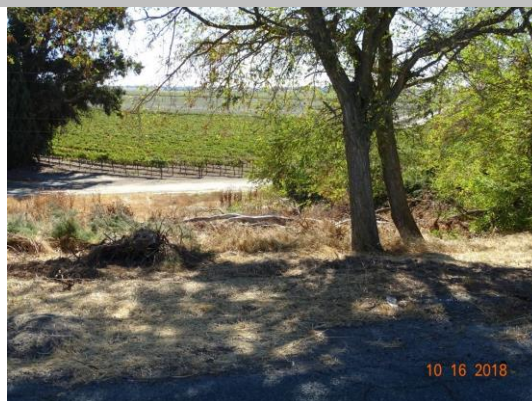
Photo 1 of 1 : FA\_2018\_RD0003\_24\_95\_20181017\_00165.jpg

LM Start	10.14	Rating **	M	Issue No.	95
LM End	10.14	Issue Type +	En	Location *	LS
Category	Earthen Levee			GPS Latitude/Longitude	
				Start	End
Item	Encroachments			38.188424 °	38.188424 °
				-121.641517 °	-121.641517 °
DWR ID	DWR_RD0003_01_s_2018_95				
Comment Code					
TR : Tree or limb					
Inspector Comment					
Remove tree limbs from land side slope.

View of tree limbs on land side slope (October 2018).

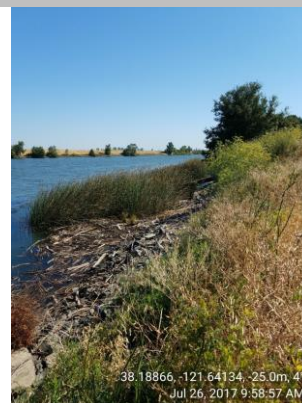
Photo 1 of 3 : FA\_2018\_RD0003\_24\_72\_20180925\_00056.jpg

LM Start	10.15	Rating **	A/W	Issue No.	72	
LM End	10.21	Issue Type +	Ma	Location *		
Category	Supplemental			GPS Latitude/Longitude		
				Start	End	
Item	2017 Storm Damage			38.188431 °	38.187803 °	
				-121.641703 °	-121.642478 °	
DWR ID	DWR_RD0003_01_f_2017_72					
Comment Code						
Inspector Comment						
Levee Evaluation Comments						
Description:District station 536+35 to 539+47, Sec. 16, T. 4 N. R. 3 E., M.D.M. The waterside slope experienced sloughing and erosion along approximately 312 linear feet of Steamboat Slough (Unit 1). Sloughing commences at approximately 1/4 of the way down the slope from the crown and extends to the rip rap.						
Site ID No:277						
Site Designation:LMA-103						
Repair Type: Erosion						
Rating:Area of Concern						
Field Date:7/26/2017						
Notes:

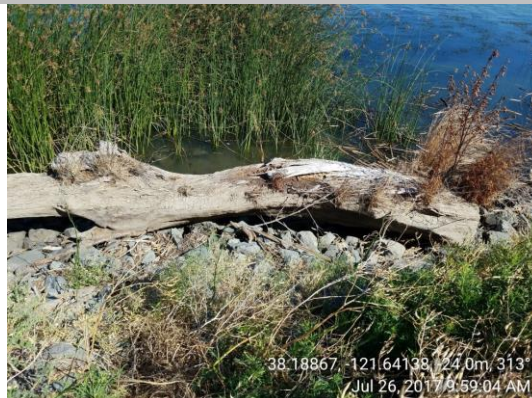
Photo 2 of 3 : FA\_2018\_RD0003\_24\_72\_20180925\_00057.jpg

LM Start	10.15	Rating **	A/W	Issue No.	72 (cont)	
LM End	10.21	Issue Type +	Ma	Location *		
Category	Supplemental			GPS Latitude/Longitude		
				Start	End	
Item	2017 Storm Damage			38.188431 °	38.187803 °	
				-121.641703 °	-121.642478 °	
DWR ID	DWR_RD0003_01_f_2017_72					
Comment Code						
Inspector Comment						
Levee Evaluation Comments						
Description: District station 536+35 to 539+47, Sec. 16, T. 4 N. R. 3 E., M.D.M. The waterside slope experienced sloughing and erosion along approximately 312 linear feet of Steamboat Slough (Unit 1). Sloughing commences at approximately 1/4 of the way down the slope from the crown and extends to the rip rap.						
Site ID No: 277						
Site Designation: LMA-103						
Repair Type: Erosion						
Rating: Area of Concern						
Field Date: 7/26/2017						
Notes:

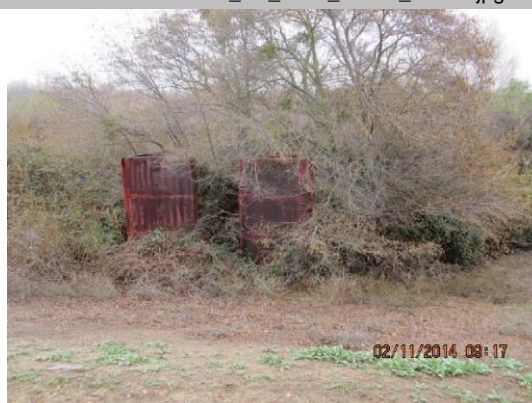
Photo 3 of 3 : UCIP\_FA\_2018\_29164\_53860.jpg

Item	DWR UCIP LMA Responsibility			38.182973 °	38.182973 °	
				-121.651645 °	-121.651645 °	
DWR ID	22349					
Comment Code						
Inspector Comment						
FS_ID:29164						
DS_ID:22349						
EP_NO: N/A						
Repair Type: Non-Urgent						
Crossing Status: Found						
UCIP Comments: Pipe appears abandoned and should be verified as having been filled with grout.						
FIELD_STRUCT_DESC: *ABANDONED* 2 of 3: 36-inch corrugated metal drainage pipe through the levee, 15 feet below the crown. Slide gate in a 48-inch corrugated metal pipe (CMP) riser on the waterside (WS) shoulder. Steel intake weir at the landside (LS) toe. Steel plate welded over the pipe on the WS toe. [Additional Reference(s): DWR Levee Log, 1993, referenced as 24 feet below the crown. USACE Sacramento O&M Manual 104, February 1960, (RM 15.20), referenced as invert elevation 24 feet below the crown].						
FS Date: 2/11/2014

Steel weir on LS toe.

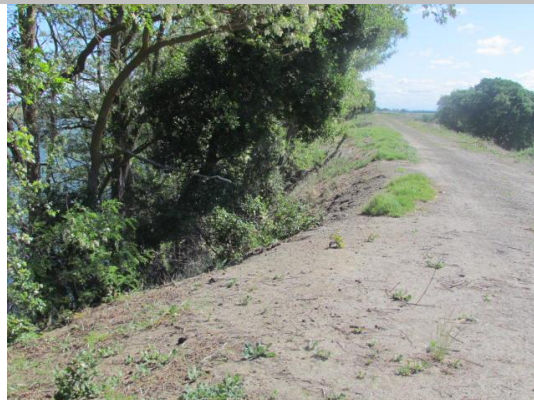
Photo 2 of 2 : FA\_2018\_RD0003\_24\_99\_20180925\_00084.jpg

LM Start	10.91	Rating **	A/W	Issue No.	99 (cont)
LM End	10.94	Issue Type +	Ma	Location *	WS
Category	Earthen Levee			GPS Latitude/Longitude	
				Start	End
Item	Erosion / Bank Caving			38.182537 °	38.182388 °
				-121.652987 °	-121.653388 °
DWR ID	DWR_RD0003_01_f_2018_99				
Comment Code					
E2 : Schedule repair of erosion site prior to the next inspection.					
Inspector Comment					
Erosion extends to waterward shoulder.

Looking north at erosion on waterward shoulder and slope.

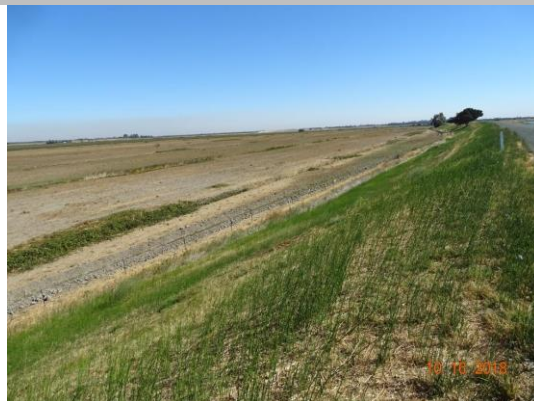
Photo 1 of 1 : FA\_2018\_RD0003\_25\_120\_20181018\_00285.jpg

LM Start	0.49	Rating **	M	Issue No.	120
LM End	0.84	Issue Type +	En	Location *	LS
Category	Earthen Levee			GPS Latitude/Longitude	
				Start	End
Item	Encroachments			38.173665 °	38.173525 °
				-121.645428 °	-121.639000 °
DWR ID	DWR_RD0003_02_f_2018_120				
Comment Code					
DT : Ditch					
Inspector Comment					
Ditch within 10' of the levee toe

View looking upstream at temporary v-ditch at the edge of the land side toe (October 2018).

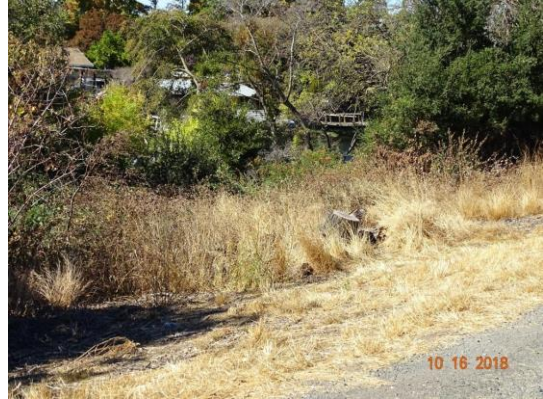
Photo 1 of 3 : FA\_2018\_RD0003\_25\_129\_20181018\_00286.jpg

LM Start	1.57	Rating **	M	Issue No.	129
LM End	1.57	Issue Type +	Ma	Location *	WS
Category	Earthen Levee			GPS Latitude/Longitude	
				Start	End
Item	Encroachments			38.168700 °	38.168700 °
				-121.627233 °	-121.627233 °
DWR ID	DWR_RD0003_02_s_2017_129				
Comment Code					
TR : Tree or limb					
Inspector Comment					
Remove remaining branches and stump of down tree from water side slope.

View of tree limbs that have mostly been removed from water side slope (October 2018).

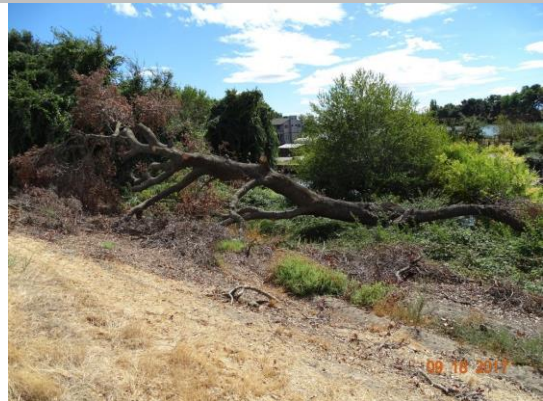
Photo 2 of 3 : FA\_2018\_RD0003\_25\_129\_20180925\_00089.jpg

LM Start	<b>1.57</b>	Rating **	M	Issue No.	<b>129 (cont)</b>
LM End	<b>1.57</b>	Issue Type +	Ma	Location *	WS

Looking east at waterside slope.

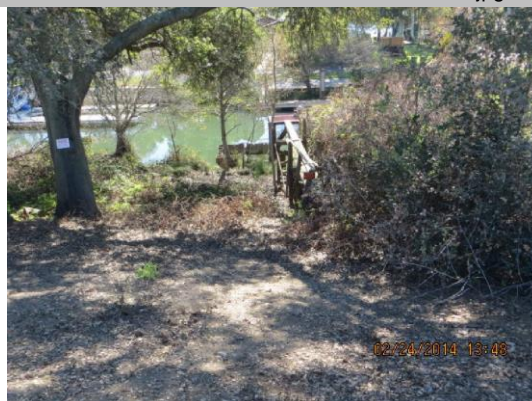
Photo 1 of 3 : UCIP\_FA\_2018\_31083\_56982.jpg

Comment Code						
Inspector Comment						
FS_ID:31083 DS_ID:22209 EP_NO: 1647 Repair Type: Non-Urgent Crossing Status: Found UCIP Comments: Sag in pavement over pipe on crown and wooden walkway to pump falling apart. Good candidate for video inspection. FIELD_STRUCT_DESC: 10-inch steel irrigation discharge pipe through the levee, invert elevation 5.8 feet below the crown. Pump on a pile structure in the channel. Service pole on the landside (LS) slope. 1.5-inch electrical conduit through the levee, 3 feet below the crown. 42-inch concrete standpipe at the LS toe. (Plans for installing a 1.5-inch electrical conduit through the levee authorized under Permit No. 1647, 1952 - Guiseppe and Emma D. Rosellini). [Additional References: DWR Levee Log, 1993. USACE Sacramento O&M Manual 104, February 1960, (RM 16.49)]. FS Date: 2/24/2014

Pump on pier on WS slope.

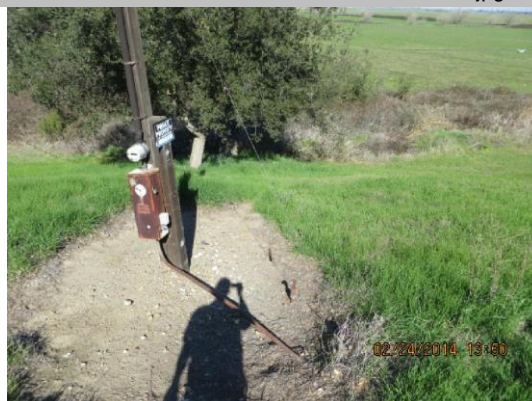
Photo 3 of 3 : UCIP\_FA\_2018\_31083\_56980.jpg

Comment Code						
Inspector Comment						
FS_ID:31083 DS_ID:22209 EP_NO: 1647 Repair Type: Non-Urgent Crossing Status: Found UCIP Comments: Sag in pavement over pipe on crown and wooden walkway to pump falling apart. Good candidate for video inspection. FIELD_STRUCT_DESC: 10-inch steel irrigation discharge pipe through the levee, invert elevation 5.8 feet below the crown. Pump on a pile structure in the channel. Service pole on the landside (LS) slope. 1.5-inch electrical conduit through the levee, 3 feet below the crown. 42-inch concrete standpipe at the LS toe. (Plans for installing a 1.5-inch electrical conduit through the levee authorized under Permit No. 1647, 1952 - Guiseppe and Emma D. Rosellini). [Additional References: DWR Levee Log, 1993. USACE Sacramento O&M Manual 104, February 1960, (RM 16.49)]. FS Date: 2/24/2014

Meter on pole on LS slope.

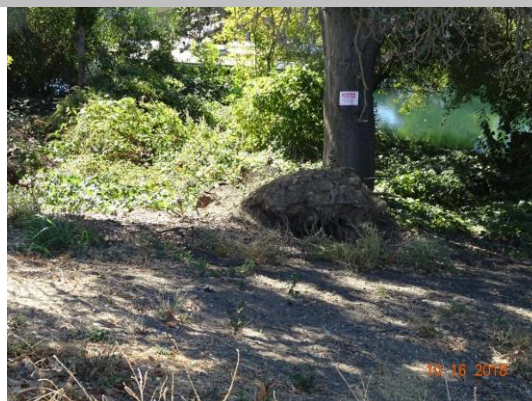
Photo 1 of 3 : FA\_2018\_RD0003\_25\_130\_20181018\_00287.jpg

LM Start	1.67	Rating **	M	Issue No.	130
LM End	1.67	Issue Type +	Ma	Location *	WS
Category	Earthen Levee			GPS Latitude/Longitude	
				Start	End
Item	Encroachments			38.167880 °	38.167880 °
				-121.625572 °	-121.625572 °
DWR ID	DWR_RD0003_02_s_2017_130				
Comment Code					
TR : Tree or limb					
Inspector Comment					
Remove remaining stump and branches from water side slope.

View of fallen tree on water side slope that has almost been completely removed (October 2018).
